## Orbiter Thermal Protection System

FS-2004-09-014-KSC (Rev. 2006)

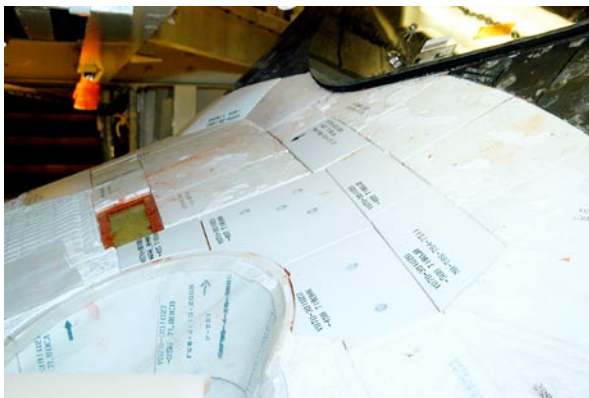
A gap test is being performed on the tiles below the windshield on the orbiter Atlantis.

The gaps between the tiles, which range from 0.028 inch to 0.200 inch, are necessary for two important reasons. The first concerns the difference in thermal expansion properties between the tiles and the orbiter airframe. When in orbit, the external temperature fluctuates by as much as 400 F. The tiles contract much less than the airframe, due to differences in the thermal

During re-entry the gap dimensions are also critical. As the orbiter descends through the ever-thickening atmosphere, pressure gradients cause the plasma surrounding the orbiter to flow. If the gaps are too large, hot gases can flow through the gaps and can cause damage to the backup surface seals (filler bar). Gap fillers are used extensively to control the gap dimensions between the individual tiles in many areas of the orbiter and in some areas to provide mechanical “padding” between the tiles.

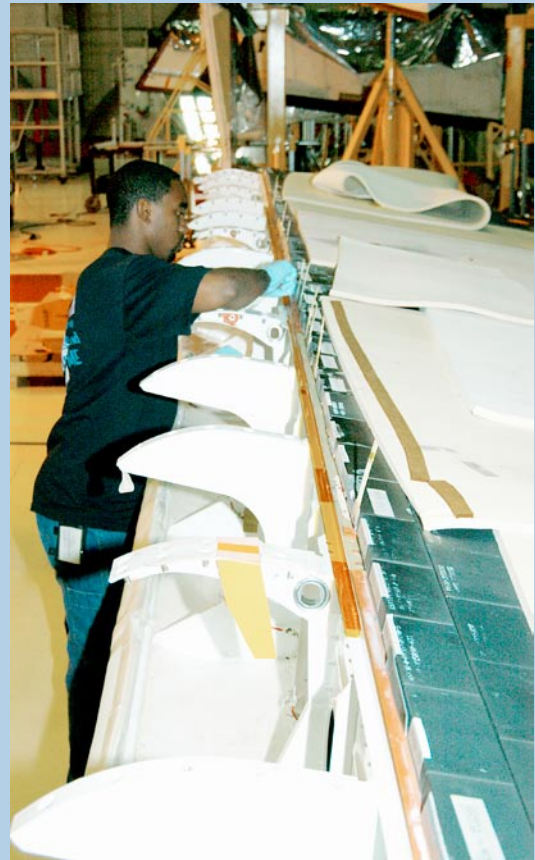
In the Orbiter Processing Facility, a technician prepares the blanket insulation to be installed on the body flap on orbiter Discovery. The blankets are part of the Orbiter Thermal Protection System's, thermal shields to protect against temperatures as high as 3,000° Fahrenheit, which are produced during descent for landing.

blankets. AFRSI blankets were used to replace the majority of the white LRSI tiles on the upper surface. A single blanket could replace as many as 25 individual tiles, although the size and shape of the individual blankets vary considerably.

The blankets consist of layered, pure silica felt sandwiched between a layer of silica fabric (the hot side) and a layer of S-Glass fabric. The blanket is through-stitched with pure silica thread in a 1-inch grid pattern.

After fabrication, the blanket is bonded directly to the vehicle structure and finally coated with a high-purity silica coating that improves erosion resistance. The blankets are semi-rigid and can be made as large as 30 inches by 30 inches.

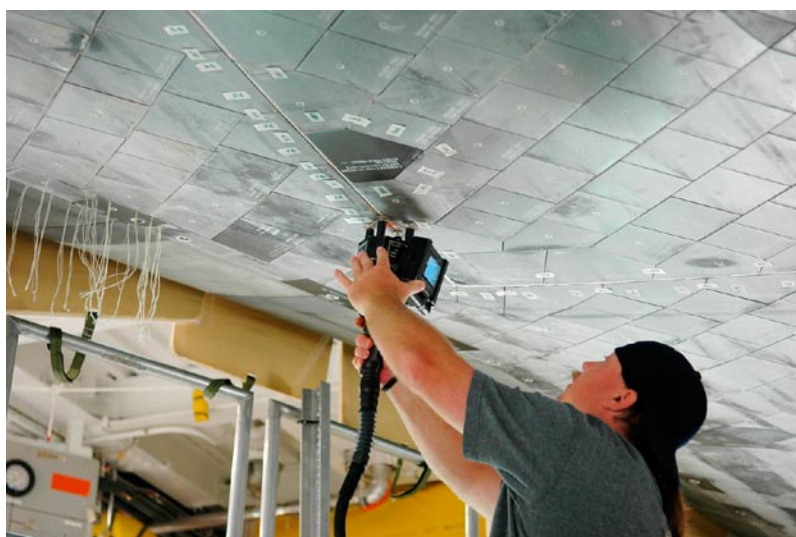
In Orbiter Processing Facility bay 1 at NASA's Kennedy Space Center, a United Space Alliance technician uses a laser tool to take step and gap measurements on Thermal Protection System tiles on the underside of orbiter Atlantis.

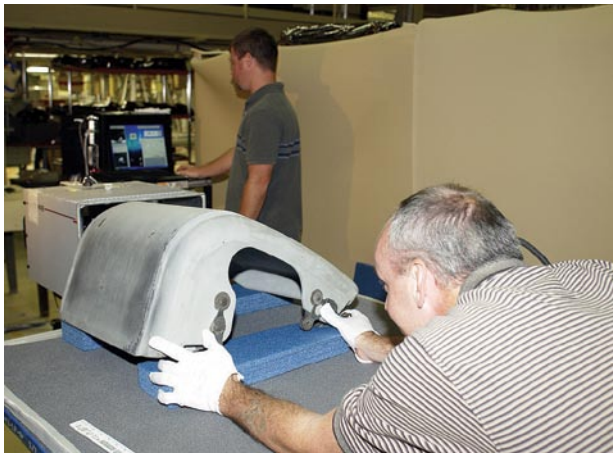
In the Orbiter Processing Facility, a United Space Alliance worker positions a reinforced-carbon carbon panel on the table to perform flash thermography.

During processing for return to flight, all RCC panels undergo extensive nondestructive inspections (NDI) and nondestructive evaluations (NDE). NDI inspections include the use of thermography and a CAT scan to detect imperfections or cracks in the structures on and below the surface. Thermography, a relatively new procedure at KSC, uses high-intensity light to heat areas of the panels. The panels are then immediately scanned with an infrared camera. As the panels cool, internal flaws are revealed. This form of NDI is in the development stage at KSC as RCC panel testing proceeds.
